Watershed-Based Participatory Sustainable Land Management using Integrated physical SWC Measure in Ilasa Watershed of Goba District, Bale Highland South-Eastern Ethiopia

Mulugeta Eshetu^{1*}, Tesfaye Ketama¹, Daniel Abegeja¹, Girma Getachow¹, Regassa Gosa¹

¹Sinana Agricultural Research Center, Soil Fertility Improvement and soil and Water Conservation Team, P. O. Box 208, Bale-Robe, Ethiopia

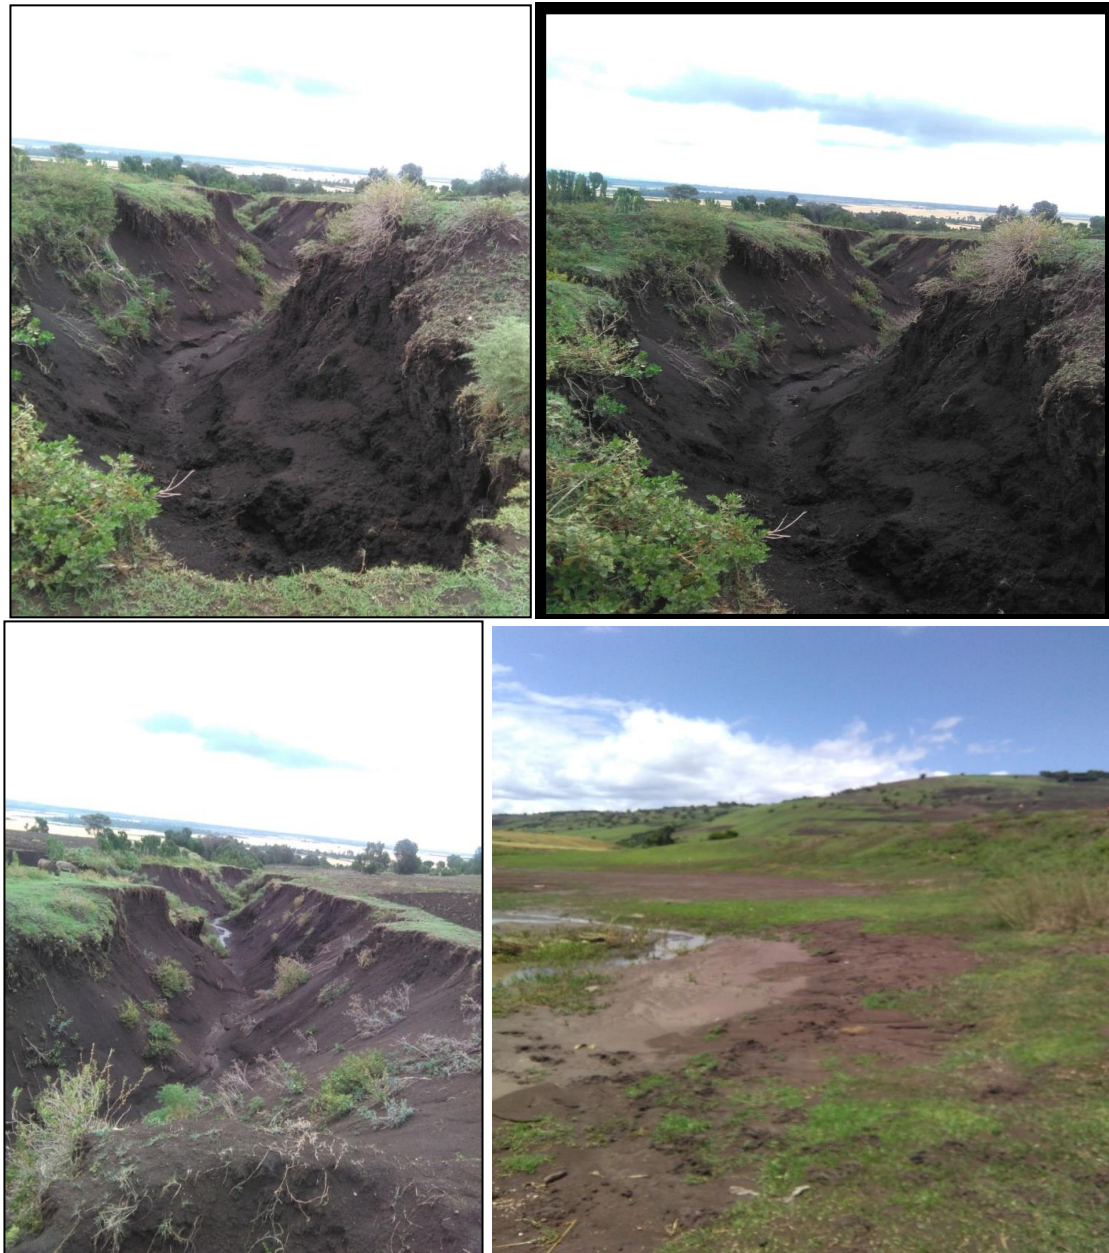
Gully formation and expansion is the major problems that causes agricultural land loose, damages different resources in the area (Figure 3). Participatory gully rehabilitation, treatments and reclamation for sustainable watershed management through gully

Figure 3: Status of land degradation and gully severity at Ilasa watershed before intervention

bund and cut-off drains as indicated (Figure 3). Similarly; Dimtsu (2018) also reported such physically integrated watershed management structures in Maego watershed of northern Ethiopia.

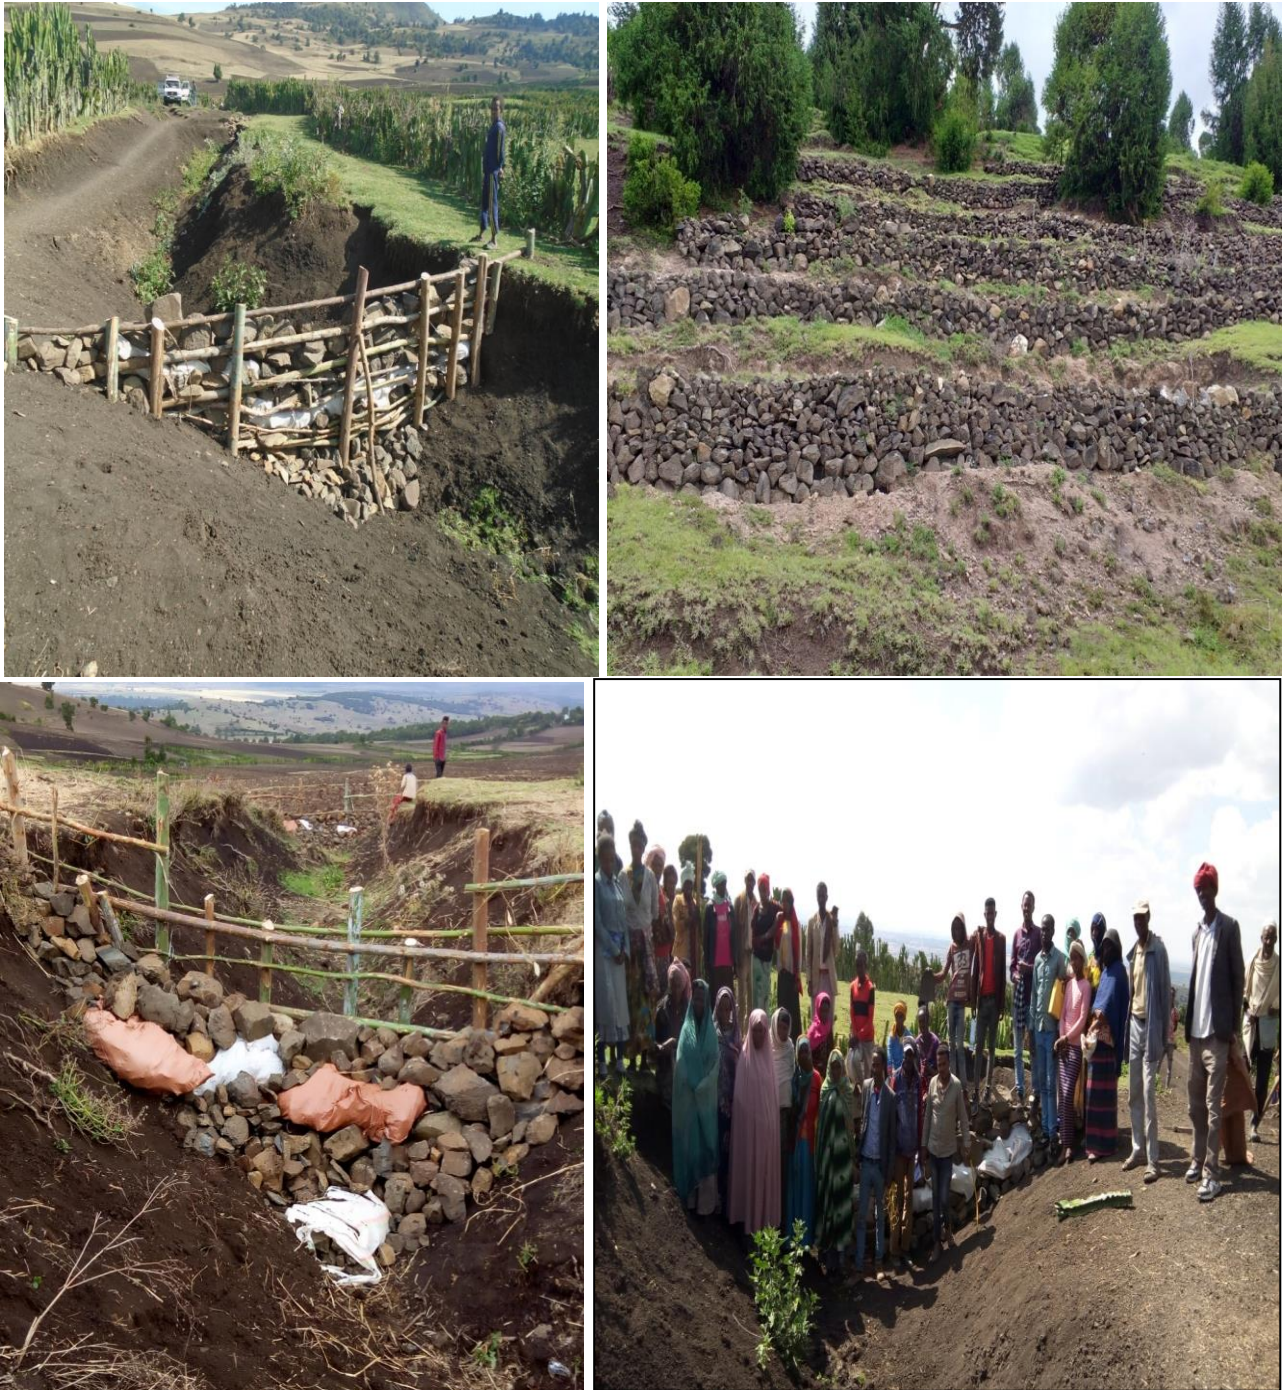
Figure 4: Picture during community-based participation in implementing soil and water conservation structures in Ilasa watershed

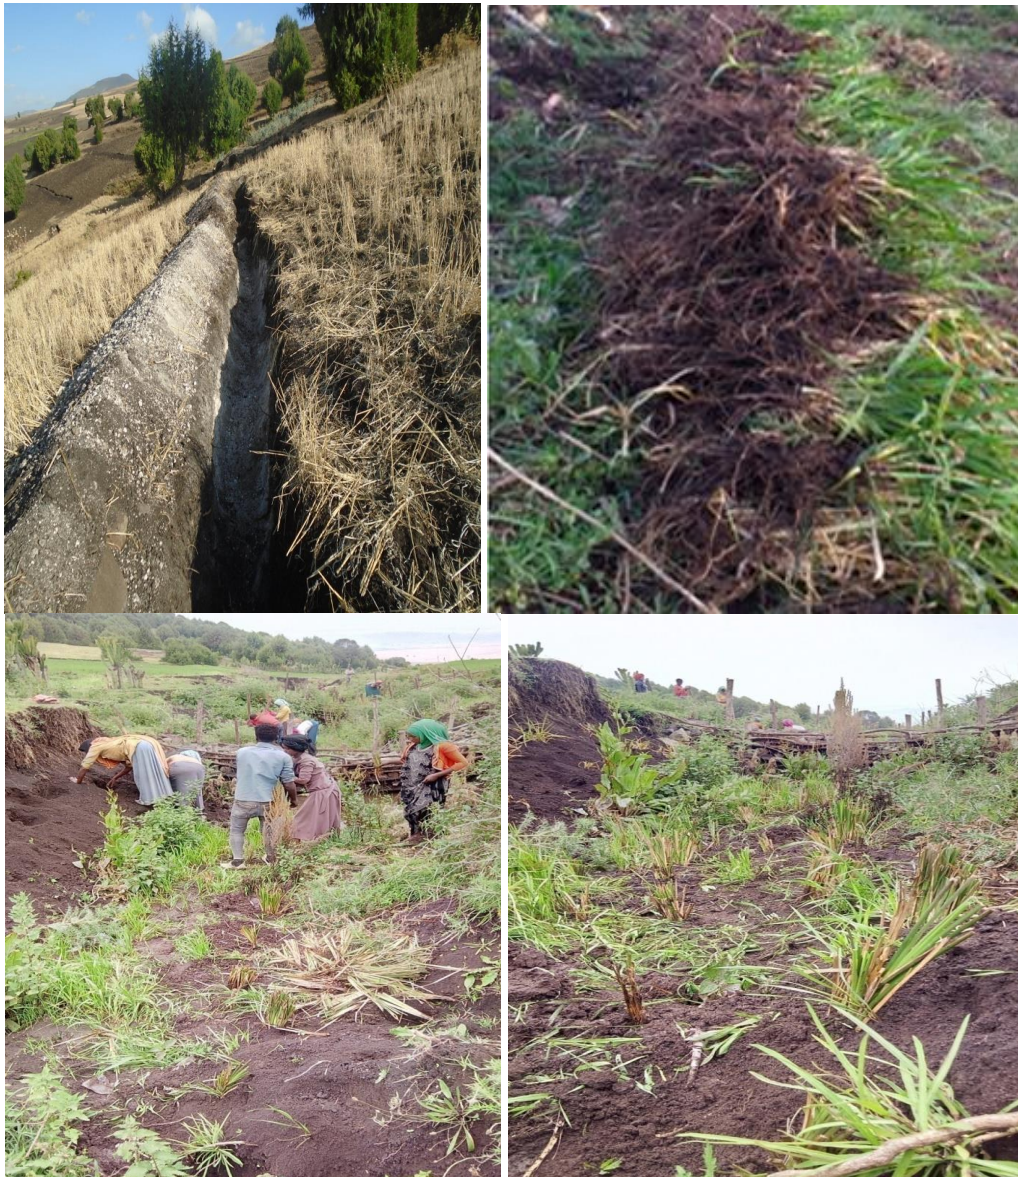
Figure 5: Planting of biological SWC measures as support of physical SWC structures

feasible, environmentally sound and replicable is paramount importance for sustainable production of Agricultural crops among this vetiver grass particularly for Bale highland (Mulugeta *et al.*, 2017). Based on this recommendation the two common multipurpose grass species vetiver and desho grass distributed in order to farmers establish Nurseries at community and watershed level, as well as also plantation on private and communal lands these two compatible multipurpose grass species were distributed for Ilasa watershed of Goba district (Table 2).

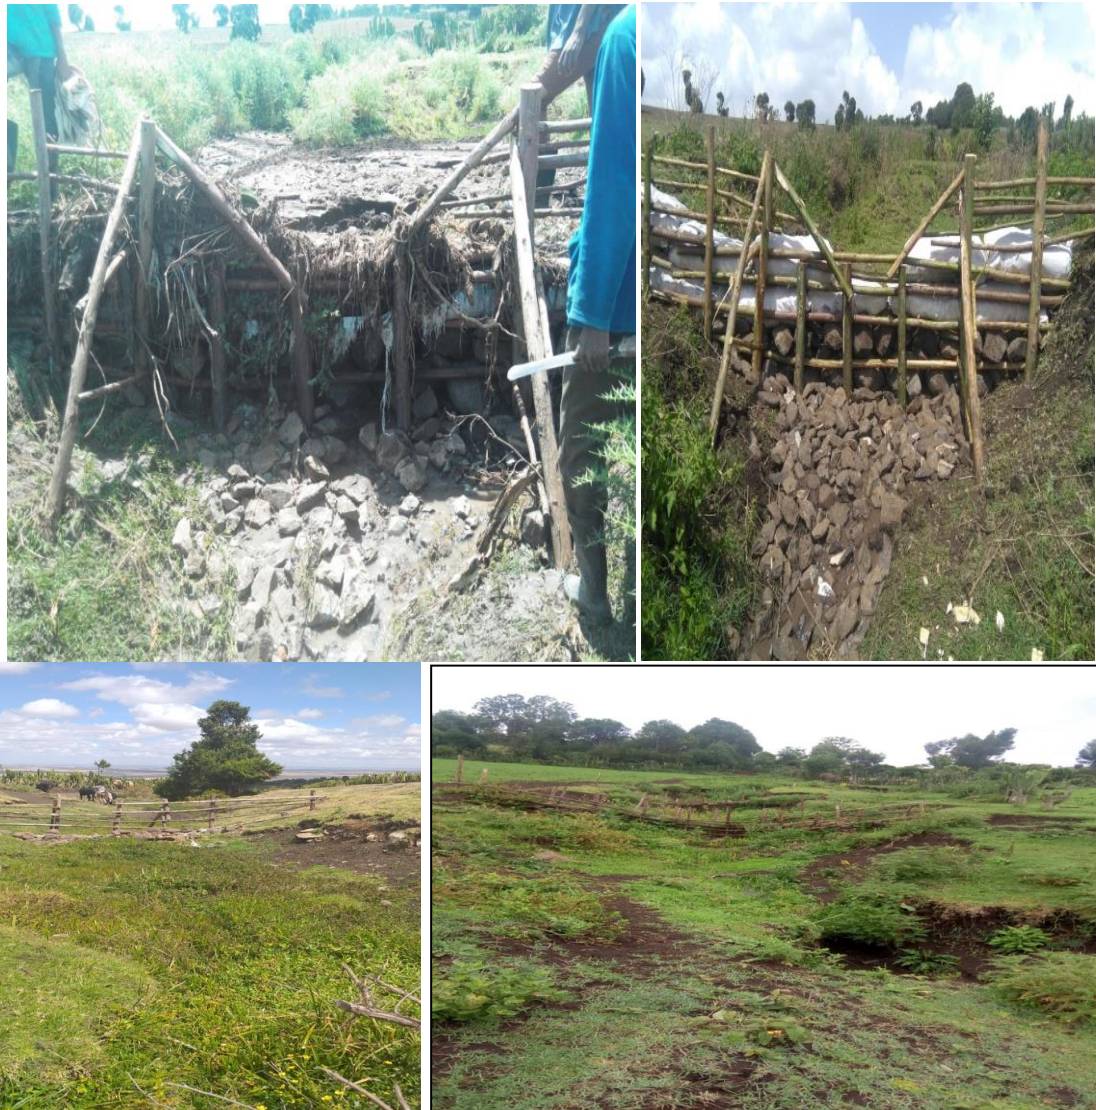
interventions in Ilasa watershed include rehabilitation of degraded land; reduction in soil erosion and associated downstream siltation; and regeneration of plant resources (Figure 6). The above success of soil and water conservation measures implemented for rehabilitating

Figure 6: Ilasa watershed status after intervention
